Accident Report

Fatality

Unnamed Kayak

11 October 2006

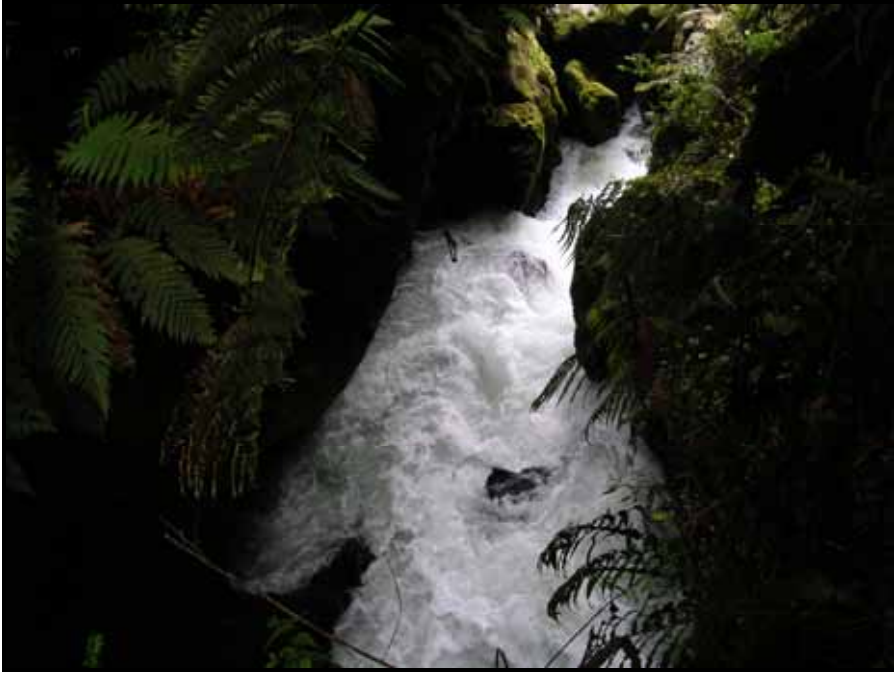
3. Rapids seen from the bush track.

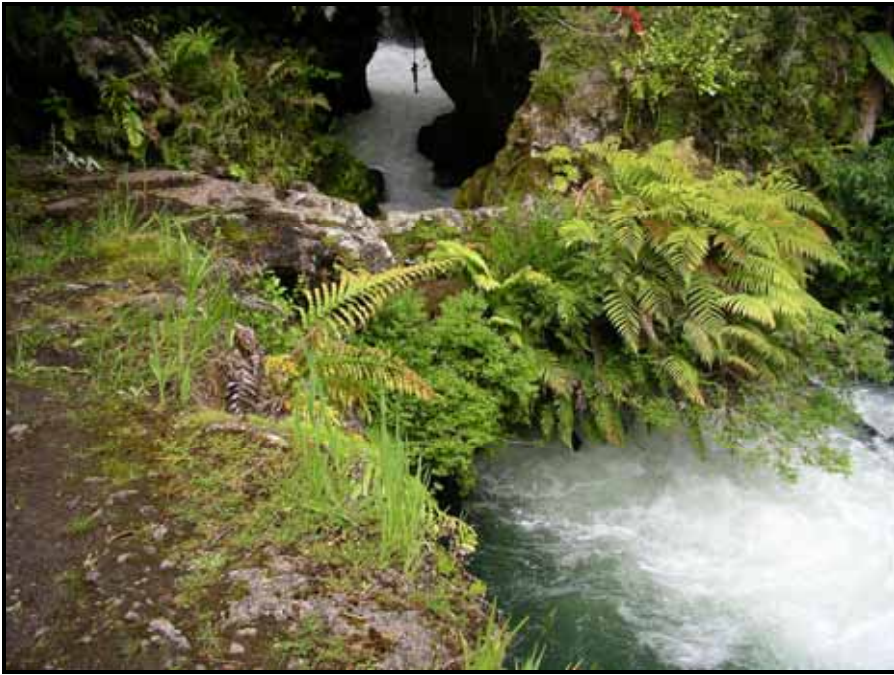
4. The natural rock bridge.

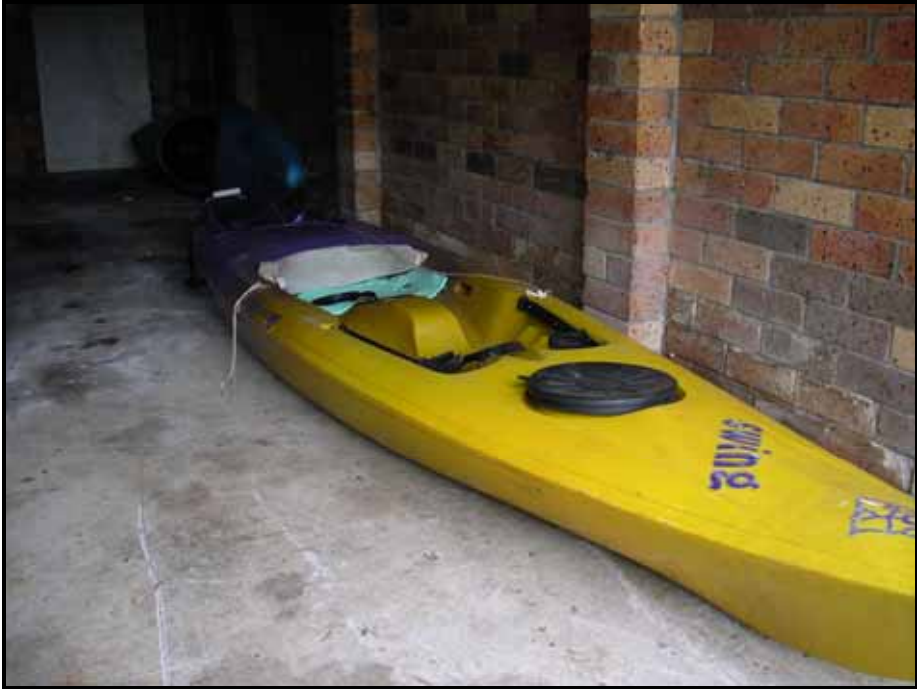
5. Skipper one's kayak. (Deceased)

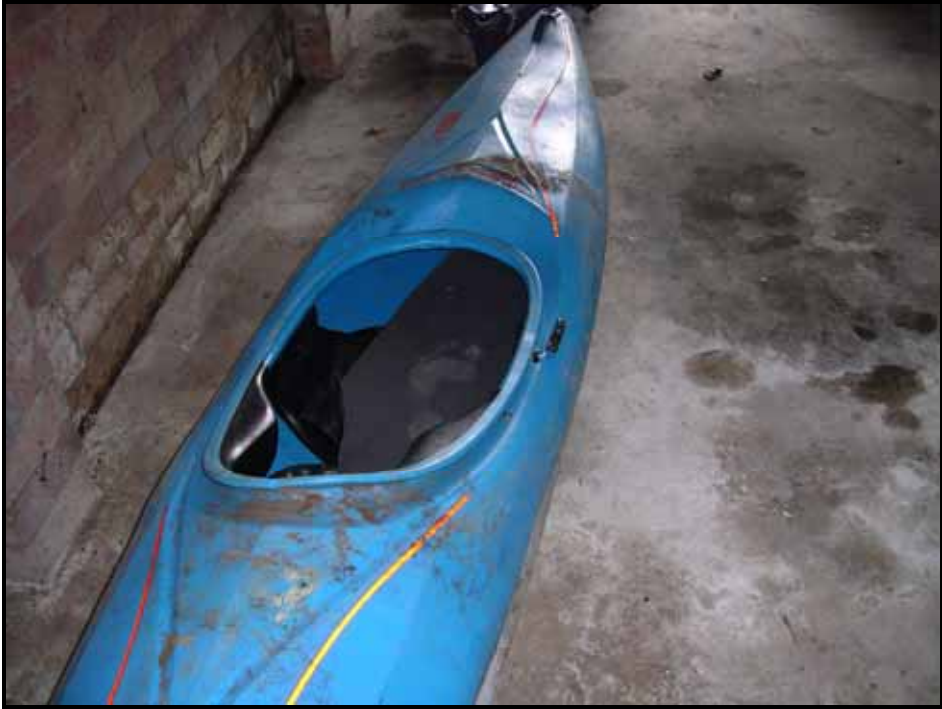
6. Skipper Two's kayak. (Survivor)
