Accident Report

Fatality

Kayak

13 January 2007

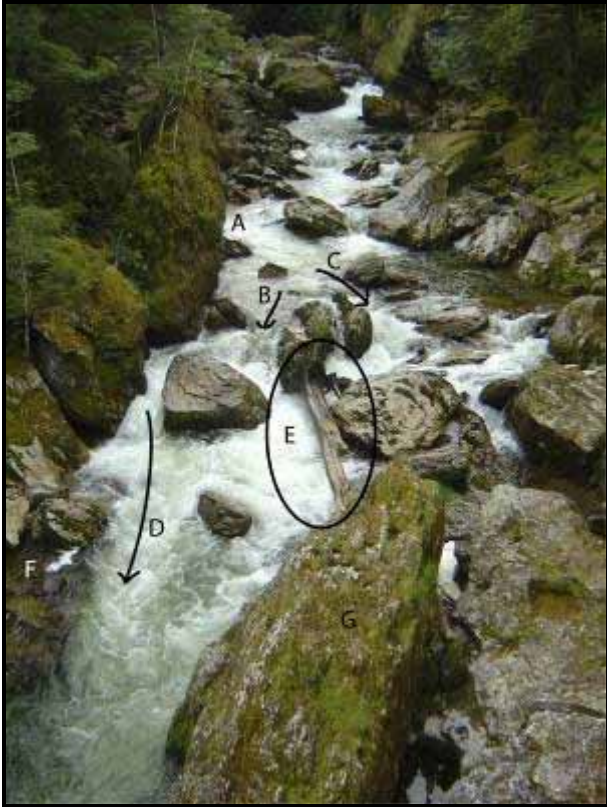
Plate 1
Accident Site Rapid

7. Dennis and his companion continued paddling down the river until they came to the rapid where the accident occurred at approximately 1500 hours. They both stopped in a small eddy on the true river right (*Plate 1, Accident site - point A*) from where they could boat scout and see the top of the rapid. The rapid was a Grade 4 rapid (*See Appendix 2*) characterised by numerous rocks with water flowing over and around them down a moderate gradient, and two obvious lines to either side of a pair of rocks (*Plate 1, Accident site - points B & C*).

8. Dennis's companion could see a clear line down the hard right of the rapid (*Plate 1, accident site - point B*). While he couldn't see all the detail of the rapid, he could see that the line he was looking at exited safely into a pool below the rapid (*Plate 1, Accident site - point D*). Based on the character of the river so far he felt confident that he could successfully negotiate any obstacles that came into view as he paddled the rapid.

The water level at the time of the accident was approximately 300mm higher.

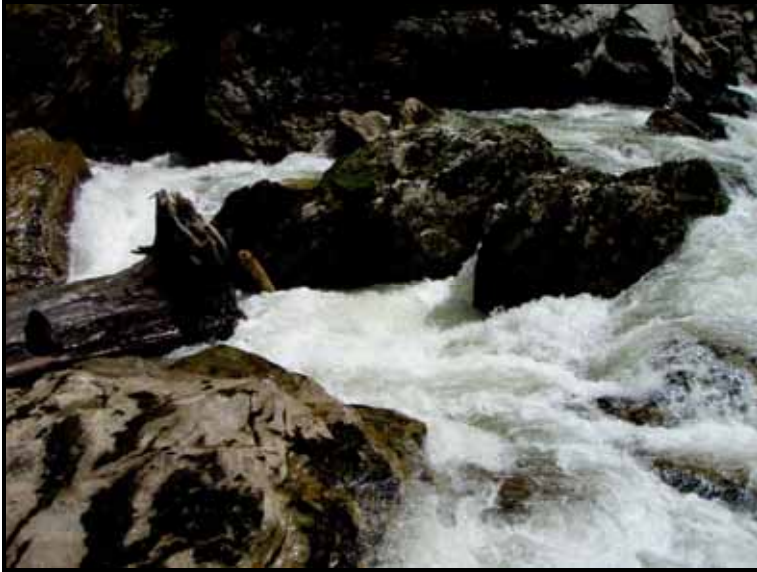
Plate 2
Accident Site (Point E)

The water level at the time of the accident was approximately 300mm higher.

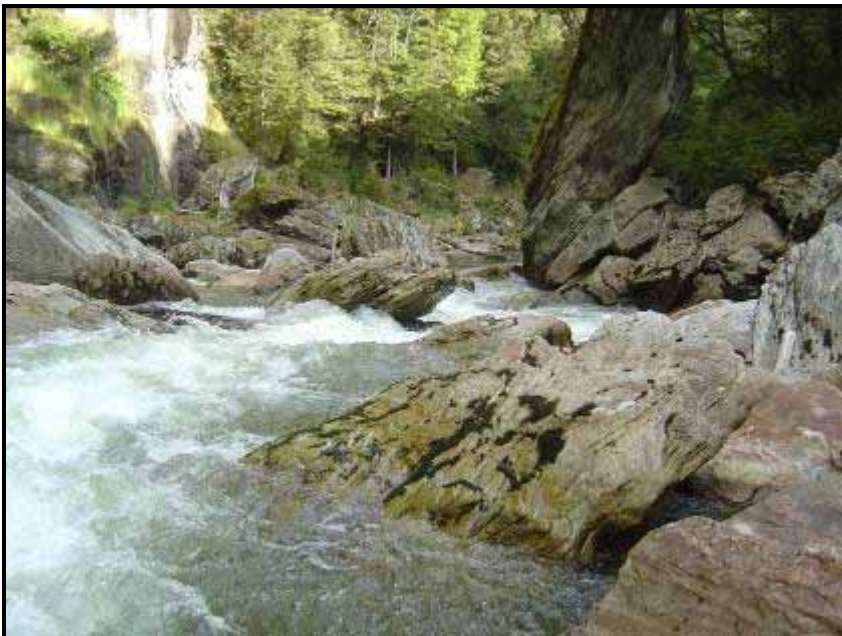
Plate 3
View of the rapid looking downstream from the eddy where Dennis and his companion began.

11. Dennis paddled out of the eddy and into the beginning of the rapid. As Dennis's companion watched, Dennis's kayak appeared to bounce off a rock (*Plate 3, point B: Point A the line Dennis's companion paddled*) and move quickly to the true left of the river, towards the line with the tree. At this point Dennis disappeared from his companions view behind rocks. His companion did not see Dennis again.

The water level at the time of the accident was approximately 300mm higher.

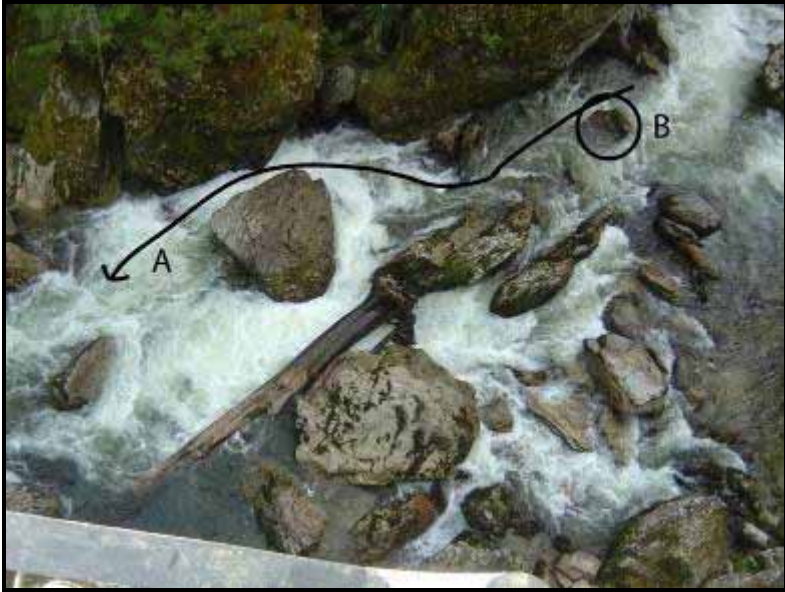
Plate 4
Accident Site showing rock (Point B) which Dennis bounced off and headed to centre left channel

The water level at the time of the accident was approximately 300mm higher.

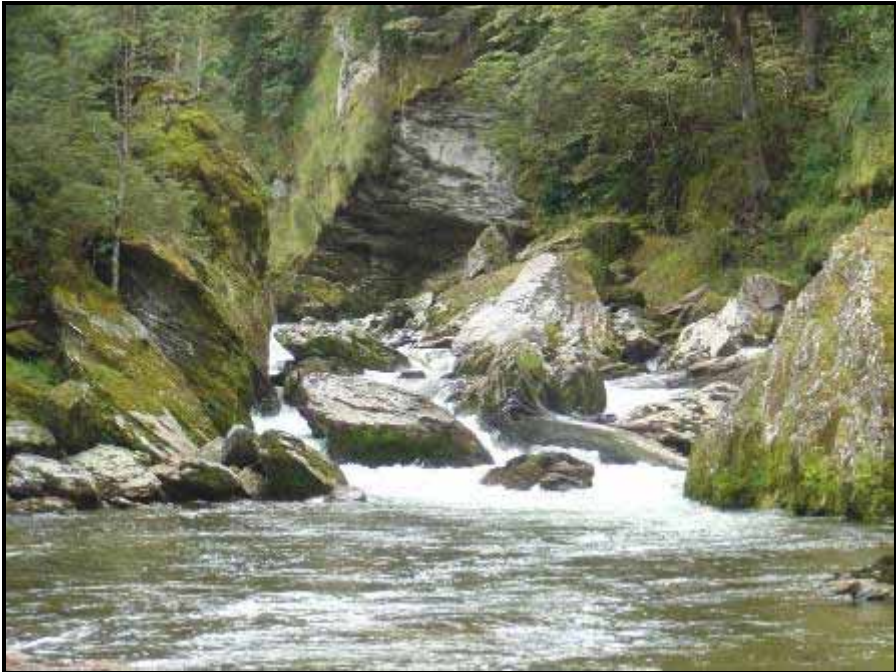
Plate 5
View of the rapid looking upstream from the true left.

The water level at the time of the accident was approximately 300mm higher.

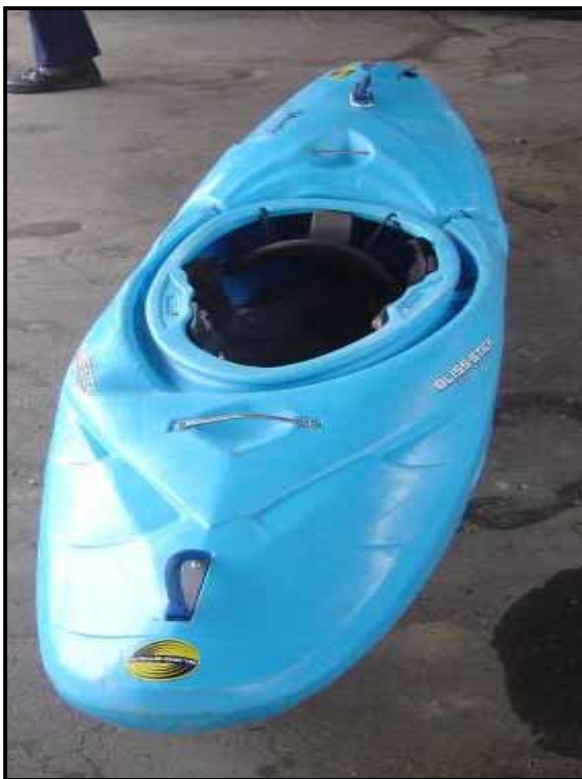
16. The kayak had sustained severe damage. There was a dent in the front of the kayak (*Plate 5*), a large dent in the rear underside of the kayak (*Plate 6*) and the kayak had folded and split behind the cockpit (*Plate 7*). Both of the foam structural pillars were displaced, particularly the rear one. The bottom of the rear pillar had slid out sideways and the top had popped free of its plastic bracket allowing the kayak to bend longitudinally. The seat had twisted and was out of place

Plate 6
Dent on right side in front of cockpit

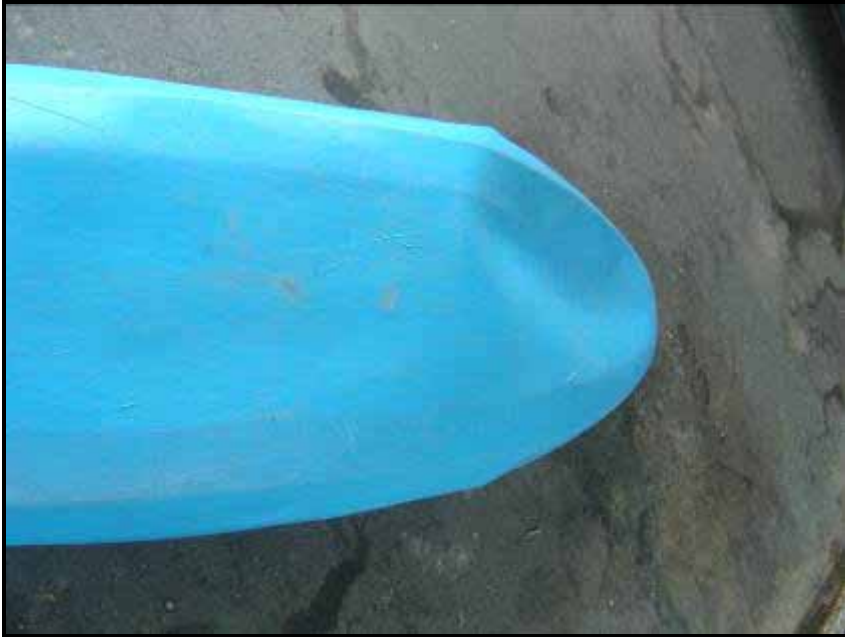
Plate 7
The dent in the rear underside of kayak

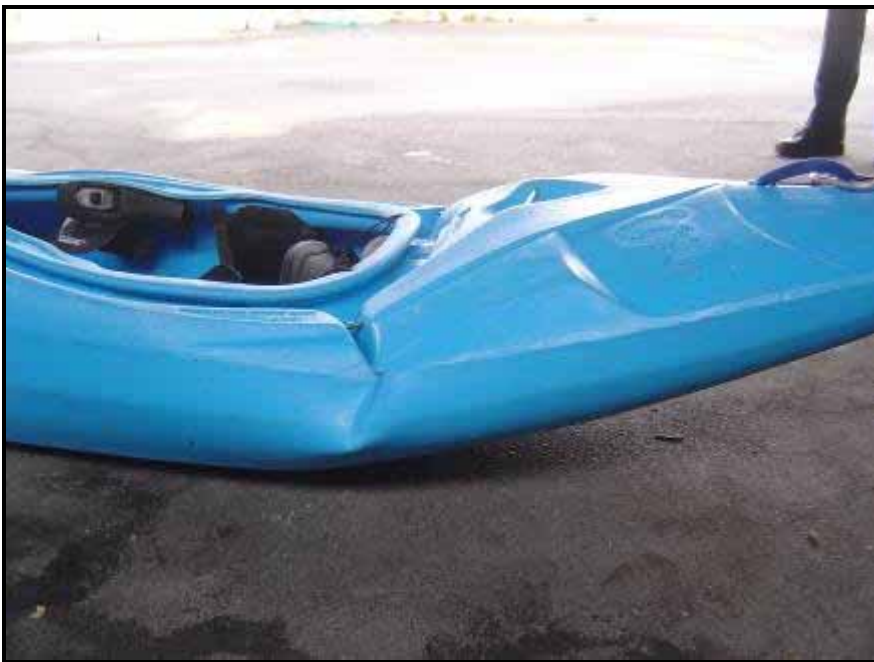
Plate 8
The fold behind the cockpit

10. It is probable that the prolonged exposure to the constant force of water against Dennis's body created a gradual lateral torque being transferred through to the kayak seat resulting in seat and pillar displacement. The displaced foam pillars and the constant pressure on the back deck of the kayak gradually resulted in the structural integrity of the kayak being compromised and the kayak being folded behind the cockpit. The manufacturer indicated that directly behind the cockpit is the weakest part of the top deck of the kayak. In the event of a severe pin the kayak is less likely to fold through the cockpit, or front deck therefore reducing the potential for entrapment in the kayak.

5. Dennis's body was entrapped underwater in his kayak from the afternoon of the 13 January through to 17 of January, approximately 3.5 days. The volume of the river fluctuated up to 20 cumecs during this time. The constant force of water on an entrapped person and pinned kayak results in substantial pressure. The prolonged exposure to the force of the water resulted in the kayak being folded.

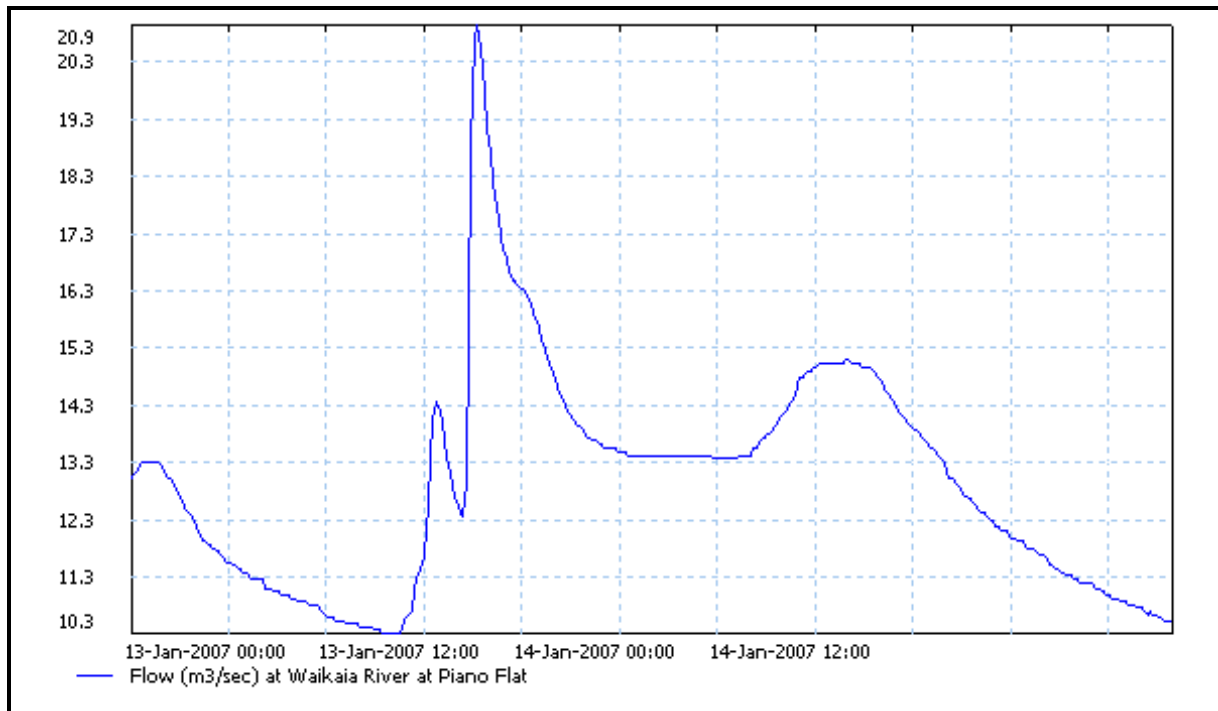
9. The Waikaia River was flowing at approximately 10.5 cumecs at the time of the accident (*see Appendix 4*). When Dennis and his companion put on, the river was at approximately 11 cumecs. It had been dropping steadily during the morning, but began to rise quickly later in the afternoon. Dennis and his companion had checked the river flow gauge the evening before the trip. It was 14 cumecs; towards the low end of the paddleable range of 10 – 50 cumecs according to the guide book they carried - *New Zealand Whitewater – 120 Great Kayaking Runs*, Graham Charles, 1999 (see Appendix 5). They were also aware that fine weather was expected for the next few days and they expected the river would continue to drop below a paddleable level. From the time of the accident until Dennis's body was recovered the river rose to approximately 20 cumecs and then dropped back down to below 10 cumecs.

River Flows recorded at Piano Flat on the Waikaia River on 13 and 14 January 2007.
